Loren Sievila

Onex 33

N331EX

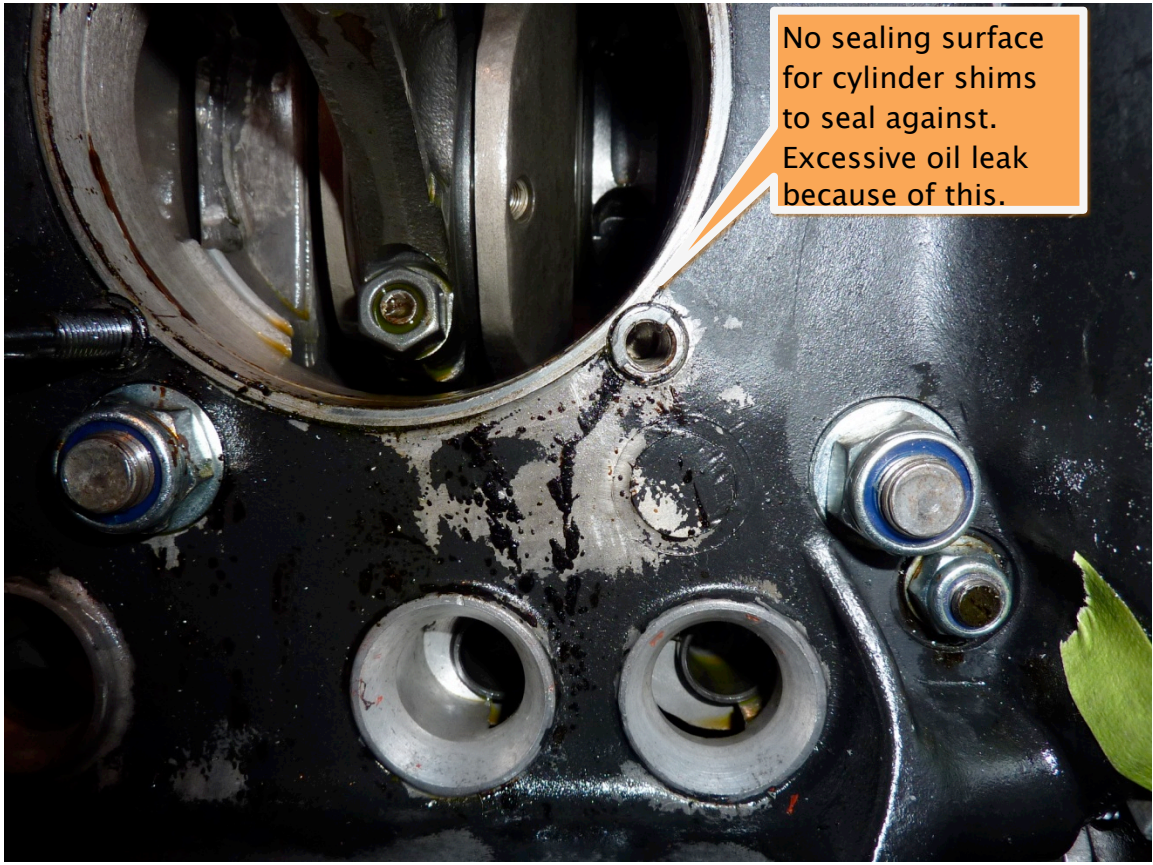
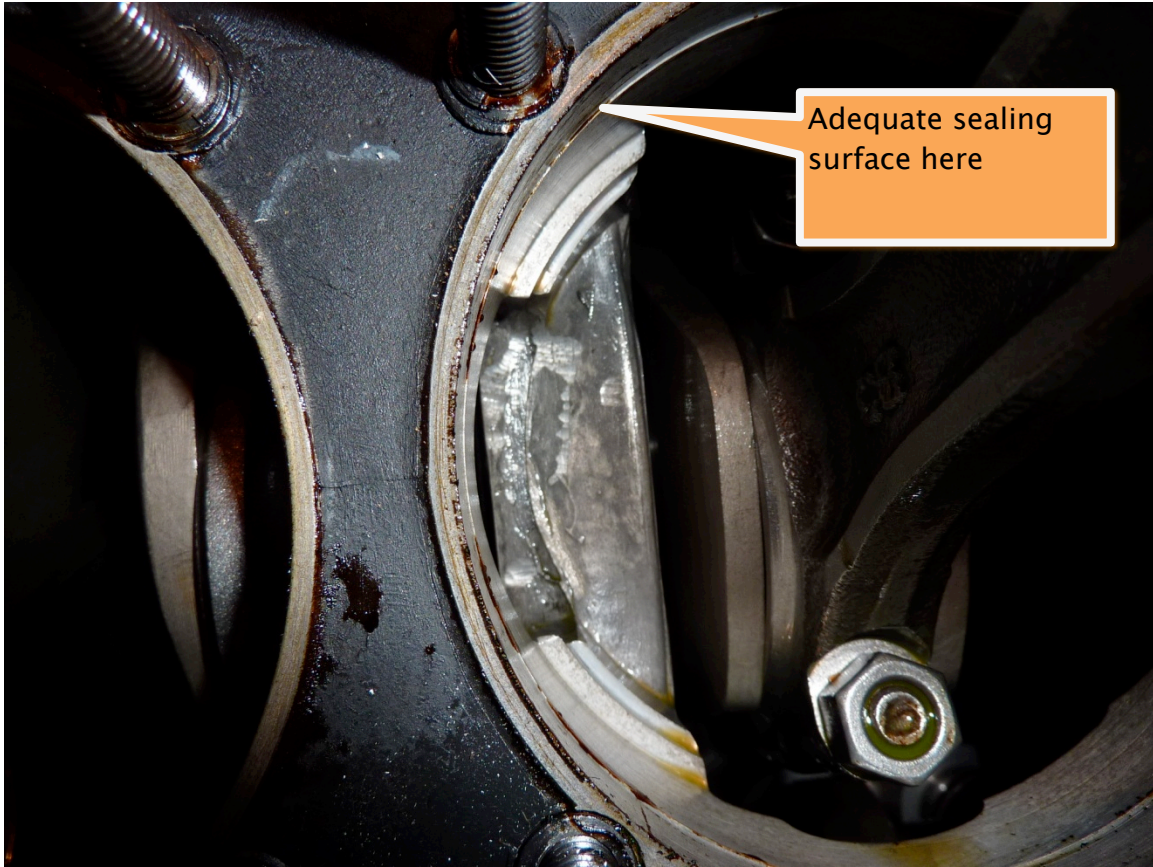
Something to watch for-when the inserts for the cylinder studs were drilled in my crankcase, the machining was slightly off center which caused the sealing surface for

the cylinder shims to be removed. If they had been off centered toward the top, I probably would not have had an excessive leak. Sonex Tech Support asked me if I used Permatex when I sent them the same picture and you can see the residual brown permatex. Permatex will not seal if there is not a surface to seal to. Also FYI the crankshaft supplied by Sonex had a flaw that caused a rod bearing to be damaged when I was assembling the connecting rod to the crank-there was a tiny burr on an oil hole in the crank that I did not see or feel when cleaning the crank. After tightening the end caps on the connecting rods, the rod did not move freely and when I disassembled I found unacceptable scratches in the bearing. Found and removed the burr, new bearings, and all was fine.
